**ROCK ISLAND LAKE DAM**

**JOHNSON COUNTY, MISSOURI**

**MO 20182**

**PHASE 1 INSPECTION REPORT  
NATIONAL DAM SAFETY INSPECTION**

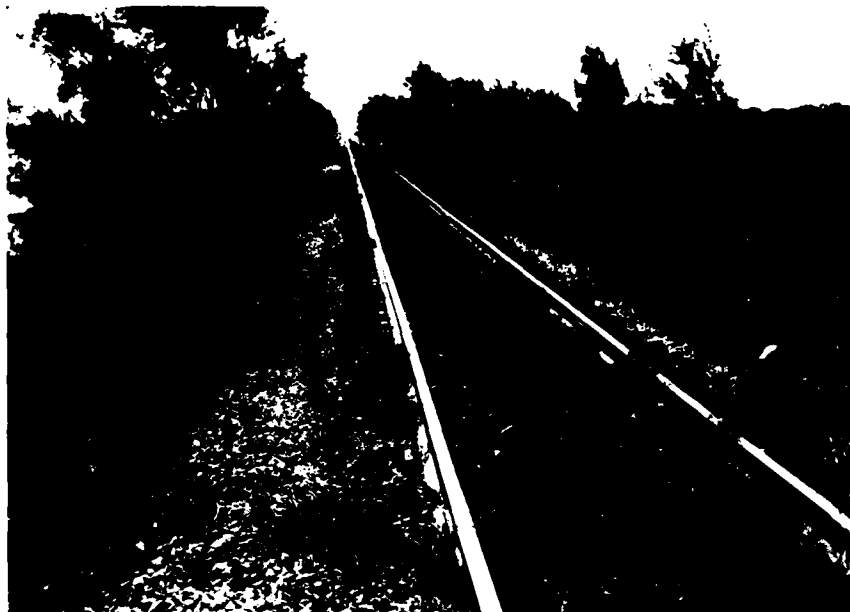
PHOTO 1: CREST OF DAM

b. Dam. The inspection team observed the following items at the dam. The ballast material which covers the top of the dam is displaced in some areas. Some bulging of this rock material adjacent to the tracks was also sighted making the edge of the crest irregular. It is believed that the smooth rounded river rock with a low angle of repose used as ballast material is probably the cause of this movement. There were a few locations along the top of the embankment where new ballast material had been placed to repair the roadbed. Growth of brush and trees was heavy on the upstream and downstream slopes of the embankment with a couple of trees as large as approximately 12 inches in diameter. A few small animal burrows were found in the embankment slopes. There was some minor erosion of the upstream slope evident above the riprap in a few locations. The lake level at the time of the inspection was approximately 0.6 feet below normal pool elevation. No cracking, sliding, or sinkholes were observed on the embankments. Also no sloughing or seepage was observed on the downstream embankment.
